# SHAPTON & PARTNERS INC.

Subject: Seismic Evaluation of City of Woodinville Annex Building Dear

SHAPTON & PARTNERS, INC. CONSULTING ENGINEERS	WOODINVILLE SCHOOL 13203 NE 175TH STREET SEISMIC EVALUATION	DATE: 06/22/01
		DETAIL NO. SK-1
FILE NO: 03502

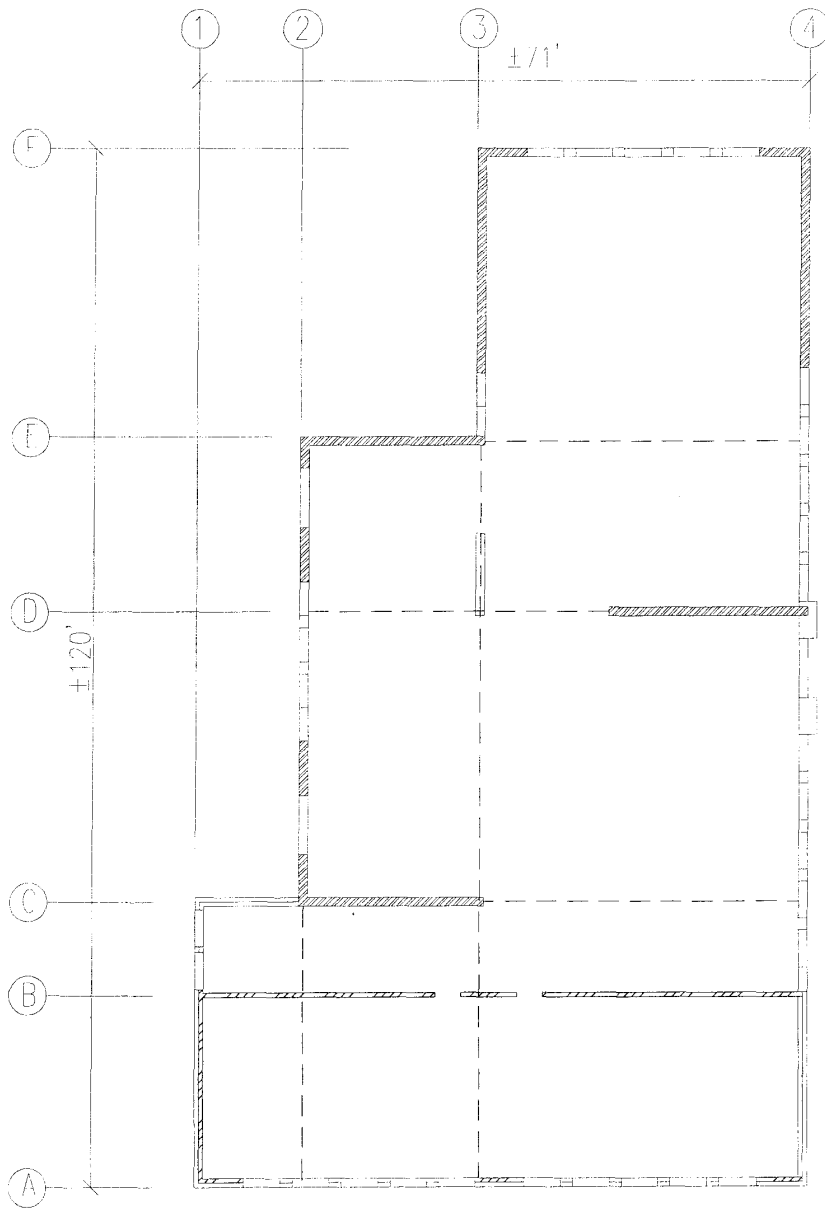
3. There is a deficiency in the strength of the diagonally sheathed wood shear walls along Line A (SK-1). This is a serious hazard as the failure of this line of bracing could be followed by the collapse of the building.

The existing structure is a two-story plus basement unreinforced masonry (URM) building, approximately 71 ft x 120' in plan (SK-1) and totaling approximately 18,300 sf (4,800 sf basement, 6,750 sf 1<sup>st</sup> fl, 6,750 sf 2<sup>nd</sup> fl). The building was constructed in three phases. The portion north of Line 3 and west of line D was constructed pre-1936. The remaining portion west of Line C was designed and presumably constructed in 1936. The portion east of Line C was designed and presumably constructed in 1948. Existing construction documents were provided for both the 1936 and 1948 work. All work prior to the 1948 addition is provided lateral support by URM walls. The 1948 work is provided diagonally sheathed timber shear walls for lateral support. The roof diaphragm is presumed to be constructed with diagonal sheathing. Likewise, the floor diaphragms are presumed to be diagonally sheathed and are topped with finished wood flooring.

Sheathed Shear Walls. The diagonally sheathed wood shear wall on Line 1 was found to possess adequate shear capacity. The diagonally sheathed wood shear wall on Line A was found to be deficient in shear capacity.
